## Case Study of Etna Neighborhood Home

A Weatherization Project completed by Comfy House Conservation Services Inc.  
As part of the ReEnergize Pittsburgh healthy Homes Incentive Program  
Summer 2014

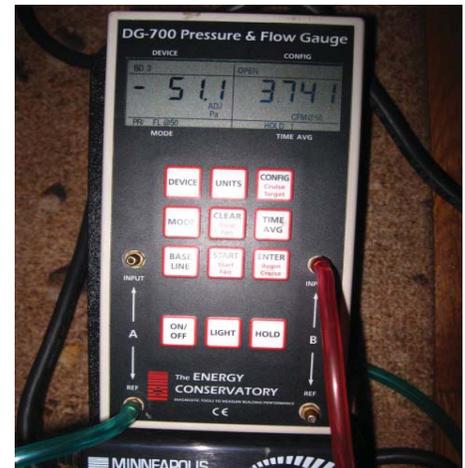
A blower door test was conducted at the house to measure overall air leakage. The blower door reading was **3,741 cubic feet per minute (CFM)** air flow needed to reach -50 Pascals of depressurization. When compared to the overall volume of the house, this equates to **10.6 air changes per hour (ACH)**. Presently, the code required ACH for new homes is 7 ACH, which means there was room for plenty of improvement in your house in terms of air sealing.

Blower Door Test-In Reading

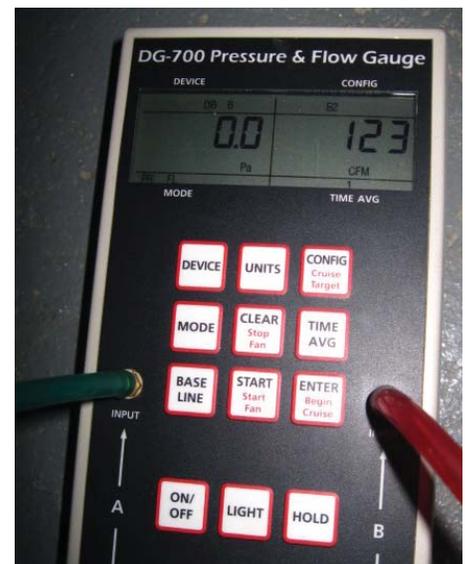
During the audit, a duct blaster test was conducted at the house to measure the air leakage in the ducts. The duct blaster reading was **123 cubic feet per minute (CFM)** air flow needed to reach 25 Pascals of pressurization in the ducts with relation to outside. The higher the CFM, the leakier the ductwork. This CFM number, while not extremely high, can still be improved upon with proper air sealing of the ducts.

Duct Blaster Test-In Reading

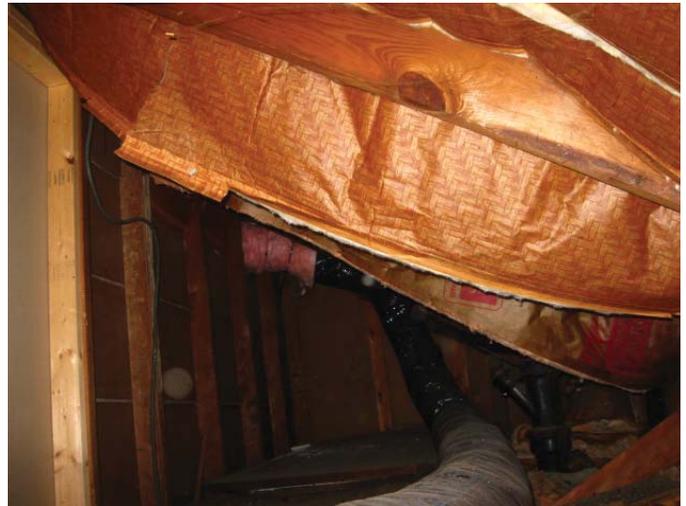
Knee walls - no insulation and no attic side air barrier. Also, insulation was installed at the rafters, where it should not be.

- 1) The fiberglass BATT insulation installed between the roof rafters, which was the wrong place, was removed.
- 2) The side attic knee walls were air sealed with spray foam, then insulated with R-13 fiberglass BATTs.

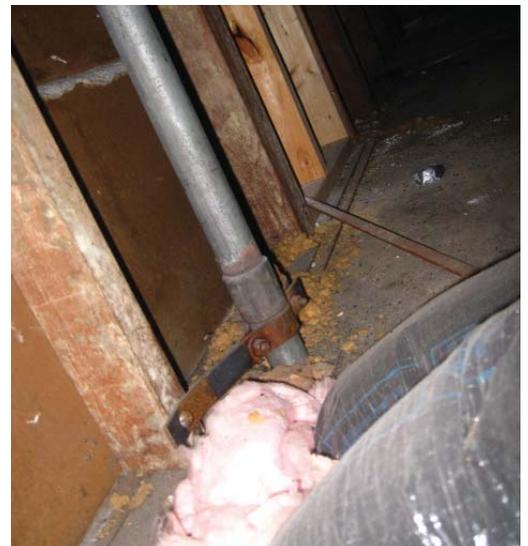
Wall top plates were not air sealed

- 5) The side attic floors, including wall top plates, plumbing and electrical penetrations, were air sealed with spray foam, and rigid material was used to seal large attic floor gaps.

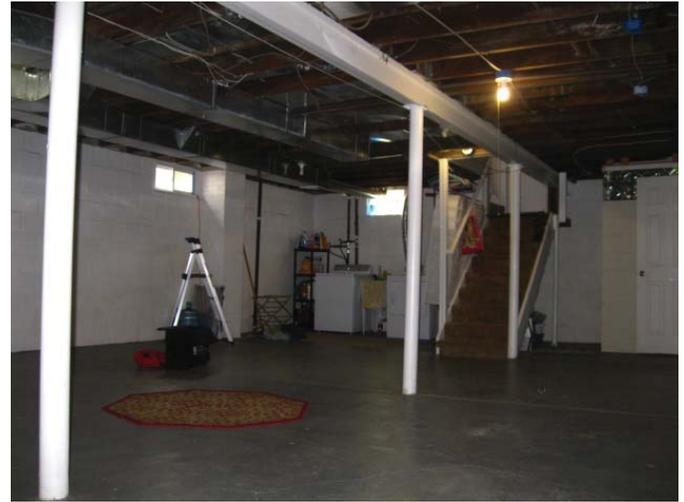
14) The basement masonry walls were not insulated.

15) There was mild staining at the bottom 2' of the basement masonry walls, behind what appeared to be a recent coat of paint, indicating a moisture issues.

Basement Walls were uninsulated

- 11) The Basement band and rim joists were air sealed with spray foam and R-10 rigid foam insulation was installed at all rim joist bays and along the entire length of all band joists.
- 12) Extruded polystyrene (XPS) rigid insulation was installed along the upper 4' of the basement walls, terminating at 3'-4" above the basement floor. The purpose of this was to prevent moisture at the basement walls from being trapped behind the insulation, leaving any moisture free to dry to the inside.

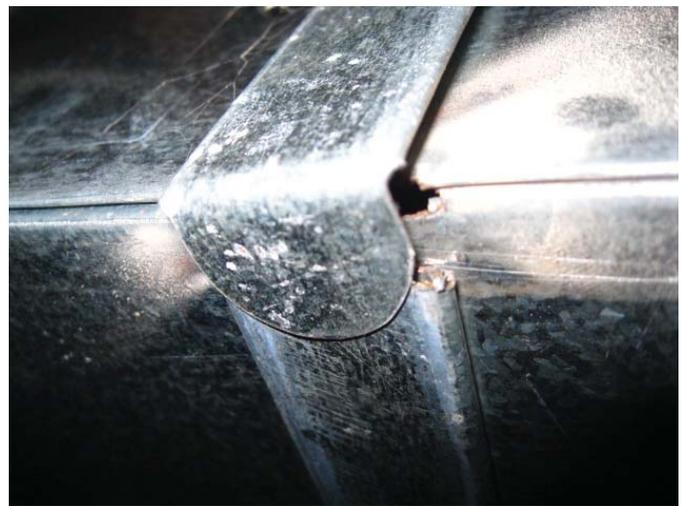
16) The HVAC supply ducts at the basement were not air sealed: the metal supply ducts had gaps at the joints and around the duct boots.

Gap at basement supply duct

- 13) The basement HVAC supply ducts, including duct boots, were air sealed with duct mastic.
- 14) All of the joints and gaps at the basement return air plenums were air sealed with duct mastic.
- 15) All of the joints at the side attic flex ducts were sealed with duct mastic.

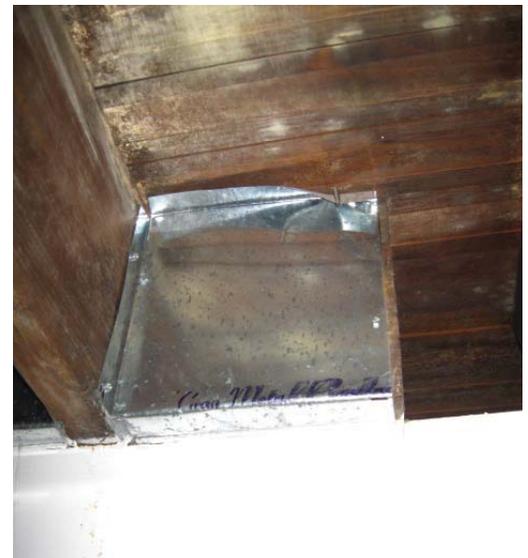
17) The return air plenums in the basement (running between the floor joists) had air gaps along the bottom and top joints.

Gaps at basement return air plenum

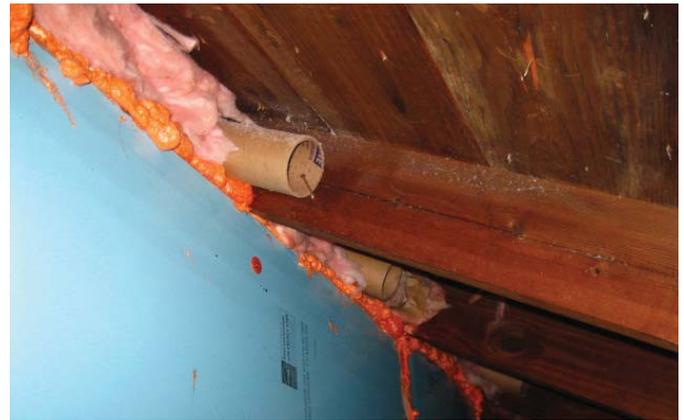
Newly installed tubes used for ventilation between lower and upper attics

- 3) Three inch diameter tubes were installed at the sloped ceiling rafter cavities between the side attics and upper attic. The tubes serve to provide air ventilation flow from side attics to the upper attic & its ridge vent.

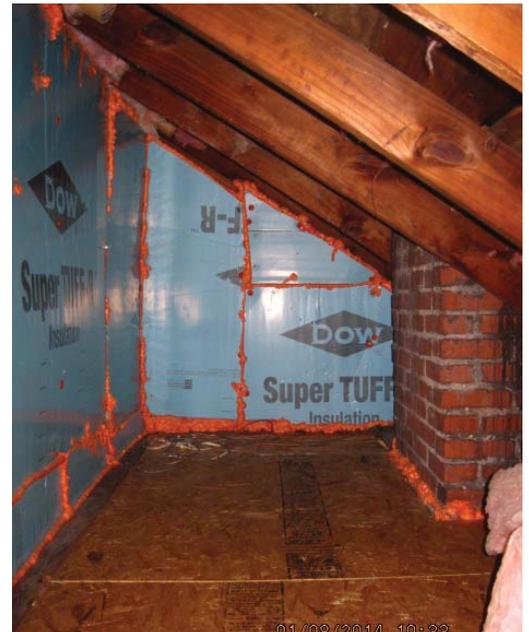
New air barrier at side attic knee walls

- 4) An air-sealed attic side air barrier was then installed. The air barrier used at most locations was an extruded polystyrene (XPS) rigid insulation, adding additional R-value to the knee wall assembly. ThermoPly was used at a few locations in lieu of XPS. After the air barrier was installed, it was air sealed with spray foam at all gaps and joints.

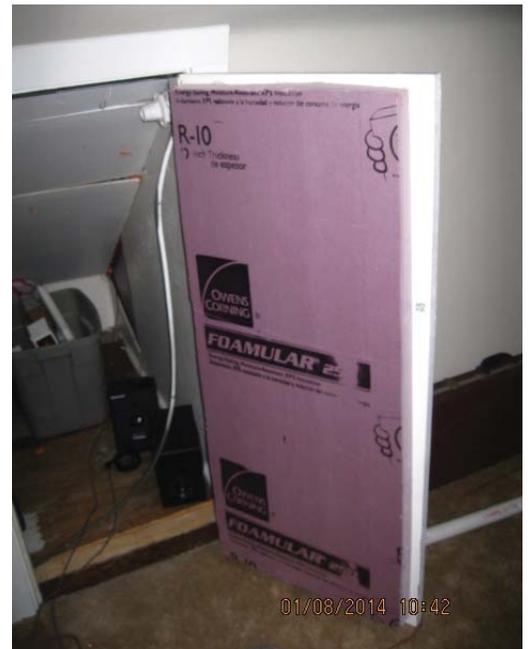
New rigid insulation at side attic doors

- 6) Gaps around the chimney at north side attic were sealed with fireproof spray foam.
- 7) Weatherstripping was installed at the four side attic access doors, and rigid insulation was applied to the attic side of each door.

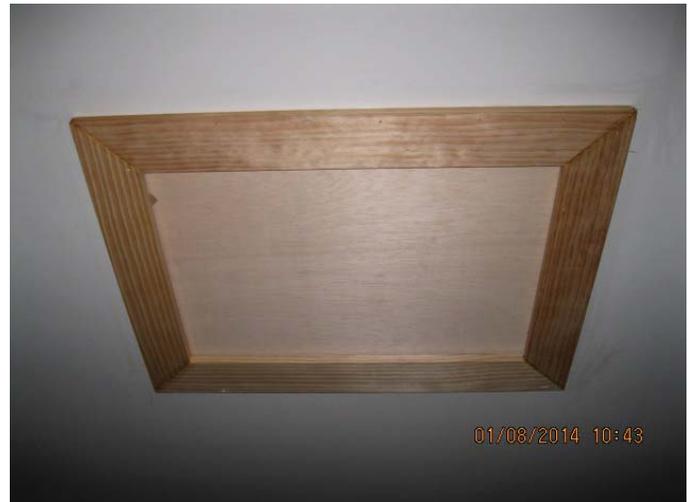
New upper attic access panel

- 8) An insulated, weatherstripped attic access panel and frame was installed at the second floor ceiling leading to the upper attic.
- 9) The upper attic floors were air sealed w/spray foam.
- 10) After air sealing was complete, the upper attic floors were insulated with blown-in loose fill fiberglass insulation above the existing fiberglass BATTs, bringing the overall R- value of R-38.

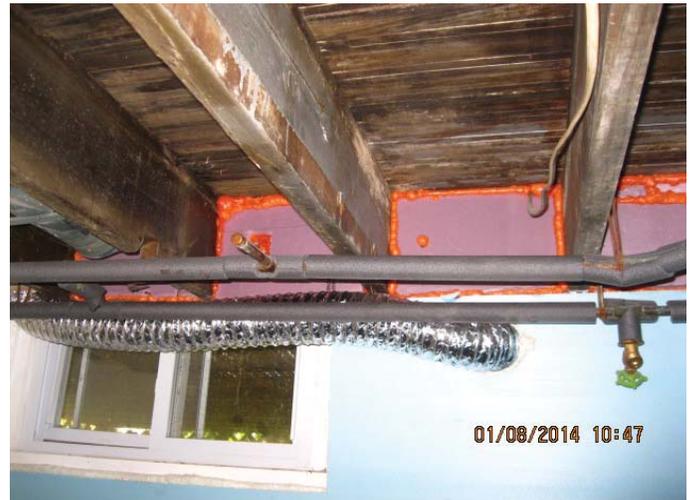
New air sealing and insulation at rim joists

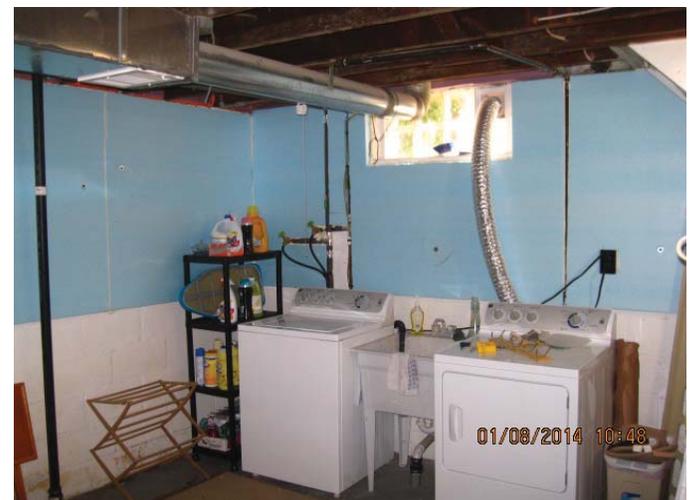
New rigid insulation at basement walls

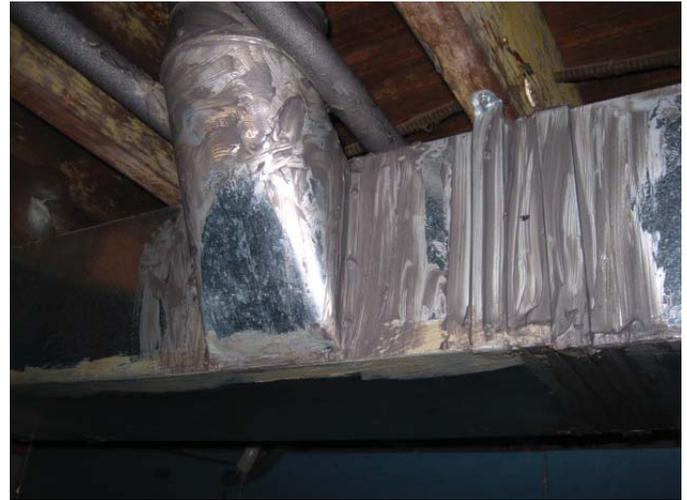
Newly air sealed ducts at basement

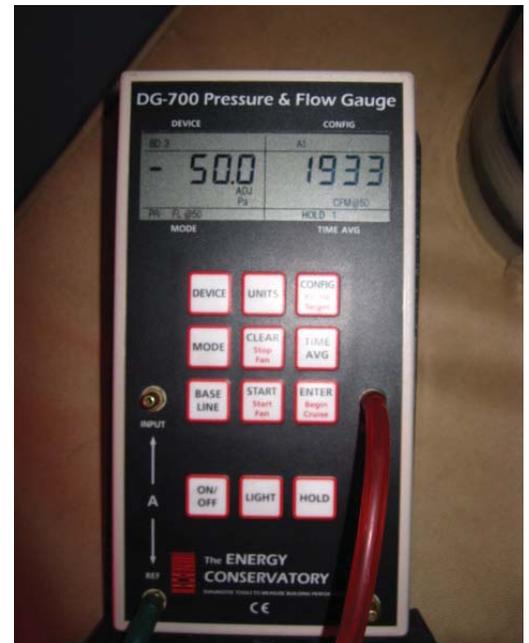
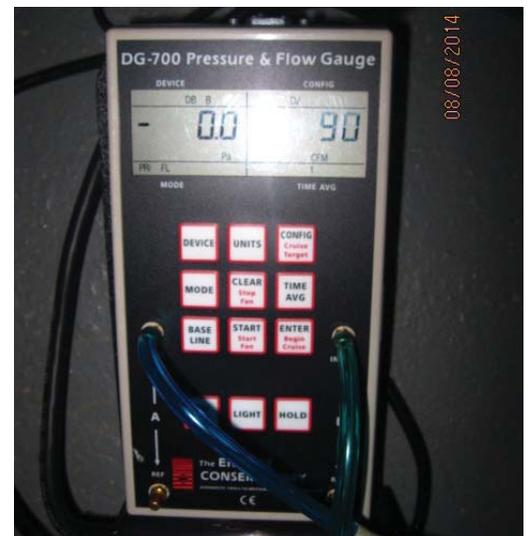
After weatherization measures were completed, a final test-out blower door test was conducted at the house. The reading on the blower door test-out was **1,933 cubic feet per minute (CFM)** air flow needed to reach -50 Pascals of depressurization. When compared to the overall volume of the house, this equated to **5.5 air changes per hour (ACH)**. This represented a **48% reduction in overall air leakage** in the home.

Final Blower Door Test-Out Reading
