## Case Study of Etna Neighborhood Home

A Weatherization Project completed by Comfy House Conservation Services Inc.  
As part of the ReEnergize Pittsburgh healthy Homes Incentive Program  
Summer 2014

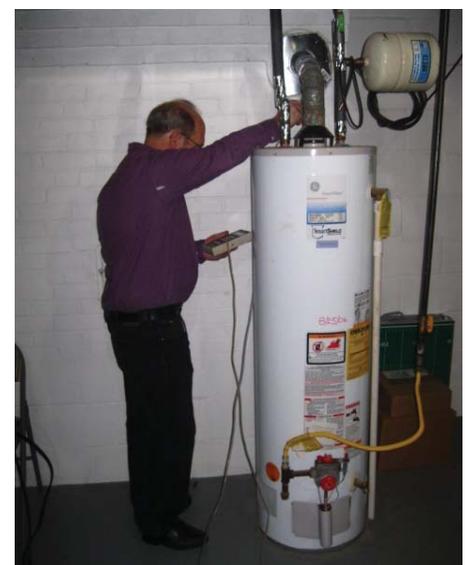
Combustion Safety Testing

The Gas Furnace and Hot Water Heater, both located in the basement, were tested for combustion safety, in addition, there was a gas range in the kitchen, which was tested for carbon monoxide levels. The following information was found:

**1) Gas Furnace:** The gas furnace is a sealed combustion unit; no combustion air/gases are exposed to the basement. The gas lines leading into the furnace and exhaust pipes leading out were inspected for gas leaks, and were found to have no gas leaks.

**2) Gas Hot Water Heater:** The gas hot water heater was tested for gas leaks (no problems) and for combustion safety in a worst case depressurization test, where the house was set up for maximum worst case “pull” of air against the water heater flue draft, so that if the test passes, you know that the equipment is operating safely at all times. In the worst depressurization test for combustion safety, we found that the water heater passes spillage (exhaust gases do not roll out from the draft hood), has adequate draft pressure at the flue, and the carbon monoxide level, both ambient (inside the basement) at the draft hood, and in the exhaust flue are well within safety limits. In addition, the exhaust flue is adequately sloped upward away from the water heater and directly to the outside.

**3) Gas Range:** The range was tested for gas leaks and none were found. The range did NOT have direct exhaust to outside, but there was a carbon monoxide detector installed nearby. The oven was turned on to 500 degrees and was tested for carbon monoxide levels: at ambient (in the kitchen right next to the range), the carbon monoxide level was well within safety limits.
